Smoke and Dye Testing Summary

High Level Sewershed

Test ID	Test Type	Date Inspected	Company / Super.	Blower MH	Ground Condition	Notification Made?	Total Length
S1028-284	Smoke	9/9/2009	ADS/TM	S11KK1019MH	Dry	Yes	906.81

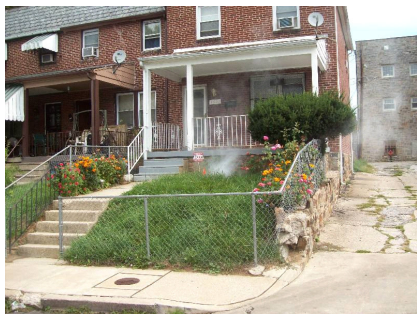
Picture \S1028-284-OB01-P01.jpg

Source Cleanout

Location Yard - front

Comments Smoke from cleanout in front yard. 4601 Homer Ave.

Comments Front of house, 4601 Homer Ave.

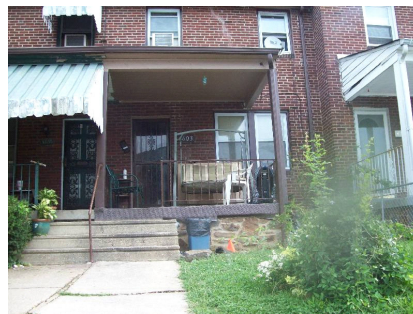
Picture \S1028-284-OB02-P01.jpg

Source Cleanout

Location Yard - front

Comments Smoke from cleanout in front yard. 4603 Homer Ave.

Comments Front of house, 4603 Homer Ave.

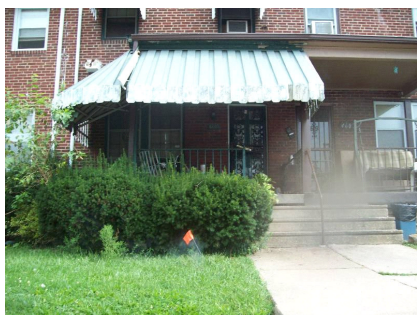
Picture \S1028-284-OB03-P01.jpg

Source Cleanout

Location Yard - front

Comments Smoke from cleanout in front yard. 4605 Homer Ave.

Comments Front of house, 4605 Homer Ave.

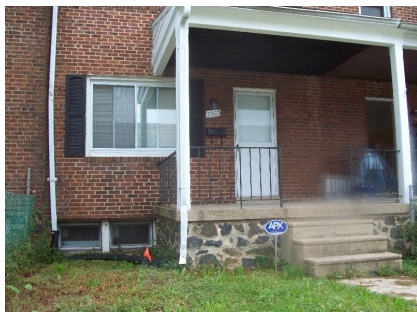
Picture \S1028-284-OB05-P01.jpg

Source Cleanout

Location Yard - front

Comments Smoke from cleanout in front yard. 3303 Royce Ave.

Comments Front of house, 3303 Royce Ave.

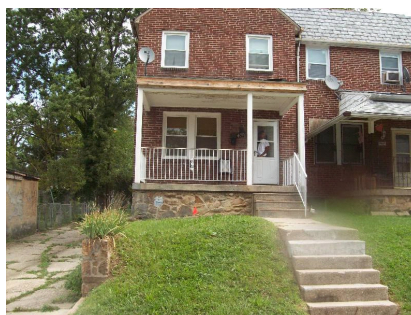
Picture \S1028-284-OB04-P01.jpg

Source Cleanout

Location Yard - front

Comments Smoke from cleanout in front yard. 4611 Homer Ave.

Comments Front of house, 4611 Homer Ave.

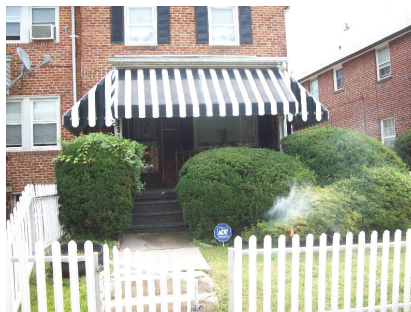
Picture \S1028-284-OB06-P01.jpg

Source Cleanout

Location Yard - front

Comments Smoke from cleanout in front yard. 3313 Royce Ave.

Comments Front of house, 3313 Royce Ave.

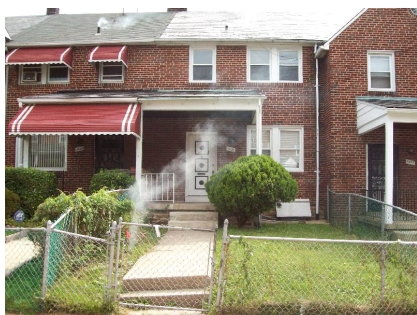
Picture \S1028-284-OB07-P01.jpg

Source Cleanout

Location Yard - front

Comments Smoke from cleanout in front yard. 3425 Royce Ave.

Comments Front of house, 3425 Royce Ave.

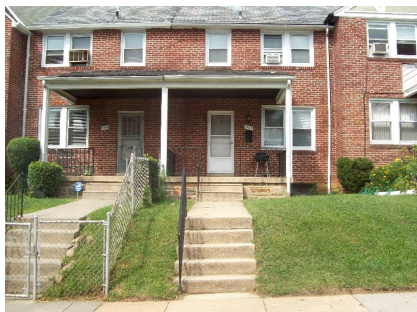
Picture \S1028-284-OB09-P01.jpg

Source Cleanout

Location Yard - front

Comments Smoke from cleanout in front yard. 3410 Royce Ave.

Comments Front of house, 3410 Royce Ave.

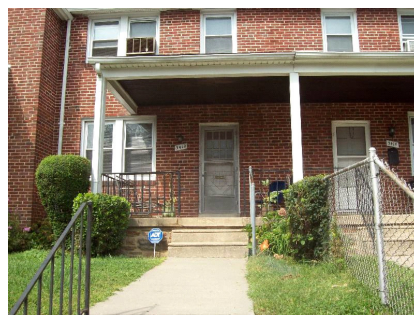
Picture \S1028-284-OB08-P01.jpg

Source Cleanout

Location Yard - front

Comments Smoke from cleanout in front yard. 3412 Royce Ave.

Comments Front of house, 3412 Royce Ave.

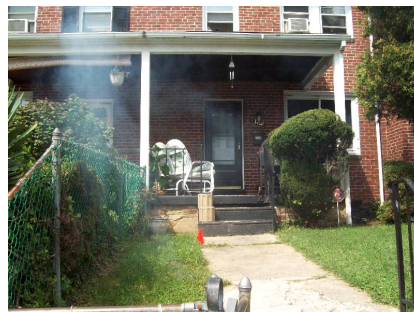
Picture \S1028-284-OB10-P01.jpg

Source Cleanout

Location Yard - front

Comments Smoke from cleanout in front yard. 3402 Royce Ave.

Comments Front of house, 3402 Royce Ave.
